ON THE SPOT CRASH INVESTIGATIONS IN THE UK: NEW INSIGHTS FOR VEHICLE SAFETY RESEARCH

Paper Number 353

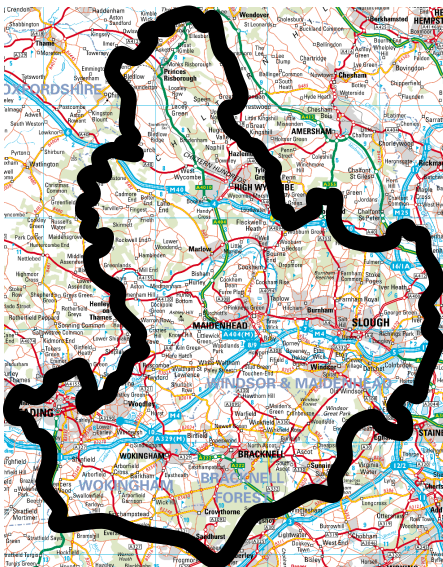
Figure 4. TRL catchment area.

The catchment areas have fixed geographical boundaries, which enable a sample of crashes to be investigated from within a known population. The areas covered by OTS are completely identifiable by details from local police injury-accident reports, so a clear statistical link is possible. The TRL and VSRC catchment areas are shown in Figures 4 and 5 respectively.

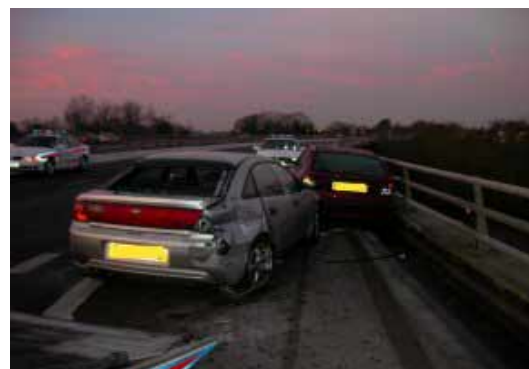
- 3) A Mazda and Renault travelling in lanes one and two respectively approached the previous crashes and upon seeing the hazard ahead, the Renault driver applied his brakes, lost control upon passing over the ice and collided with the Mazda. The vehicles rotated and come to rest against the crash barrier on the hard shoulder facing the on-coming traffic.

Figure 7. Resultant position of the Renault and the Mazda, neither vehicle has any major structural damage.

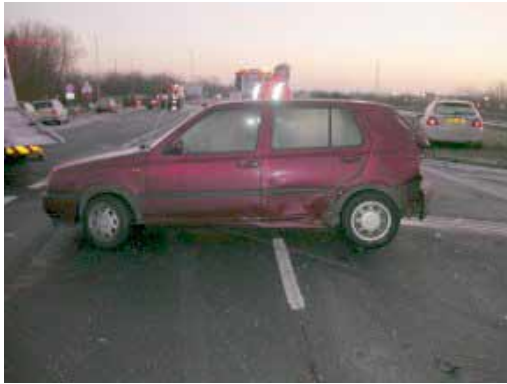
- 4) A driver of a second Mazda swerved to avoid debris in the carriageway and collided with a Vauxhall Omega.
- 5) The driver of a Volkswagen Polo travelling in lane two saw a car's headlights shining in his direction up ahead. He braked and the vehicle travelling behind collided into the rear of him. The Polo rotated and had impacts with two other vehicles.

Figure 8. The Volkswagen Polo came to rest straddling both lanes of the carriageway. The Rover which avoided the collision can be seen to the right of the picture.

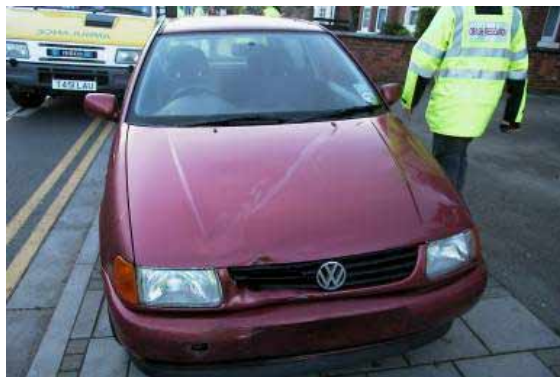
Figure 11. Direction of travel of the motorcyclist can be seen as a dried area upon a wet bonnet. Condensation upon the windscreen is also visible

The external surface of the car's bonnet and internal surfaces of the windscreen and side windows were covered with condensed moisture. This is a common phenomenon on early mornings in damp weather conditions and the driver had not attempted to clear the moisture from the glazing before starting her journey. The moisture was seen to limit the driver's vision through front and side glazing. Upon inspection of the vehicles, it was possible to

Several causation factors were identified, the driver of the Polo's failure to prepare the car safely for the journey, her lack of observation of other road users, and the conspicuity of the scooter rider, who was dressed in dark clothing.

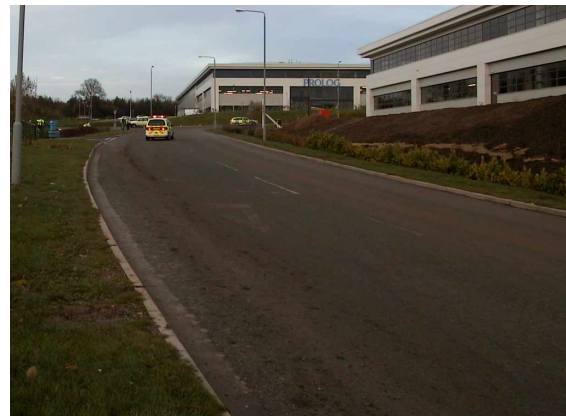
The VSRC OTS team attended a crash that occurred at 14:00hrs in November 2000. The crash location was a single carriageway in an industrial estate. Some building work was being carried out on the site, which resulted in contamination of the road surface with soil.

Figure 15. Contamination of road surface with soil.

The excessive speed and relative lack of experience of the young driver caused the crash. The contaminated road surface would have made the driver's attempted manoeuvre more difficult to complete successfully.

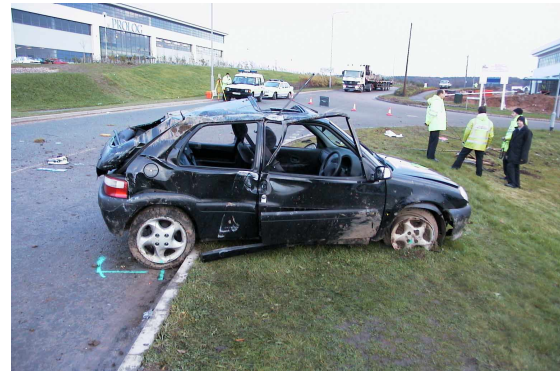
An 18-year-old male was driving a Citroen Saxo, with 2 passengers. The driver often used the industrial estate as a short cut. The car drifted onto the opposite carriageway as it travelled around a sweeping right hand bend. Upon approaching the junction the driver attempted to move back onto the correct side of the road, using a combination of steering and braking. Due to his excessive speed and the greasy road surface the driver lost control. The vehicle mounted the grass verge to the near side and rolled through 360° coming to rest on its wheels.

Figure 17. Final position of Saxo.

The crash highlighted the very high risk of injury if occupants are ejected from a vehicle. The use of seatbelts would almost certainly have prevented the ejection and, given the other two occupants' slight injuries, saved the life of the deceased.

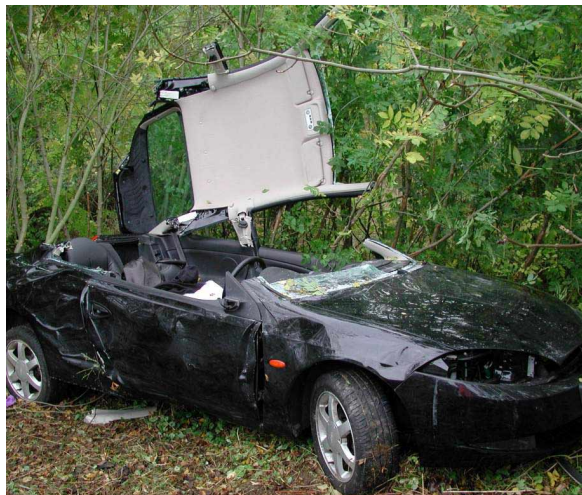
The car drifted towards the central reservation and struck the barrier. The driver over corrected making the car yaw and subsequently leave the motorway,

Figure 19. Ford Cougar as found by OTS team at the bottom of a steep embankment

The investigating team believed the cause of the crash to have been that the driver fell asleep at the wheel. However, although the driver admitted to being tired, he did not state that he fell asleep.
